Manhole Inspection Summary

Manhole # S25GG1002MH

Insp Date: **1/17/07 2:03 PM**

Location Address: **1119 WELDON AVE**

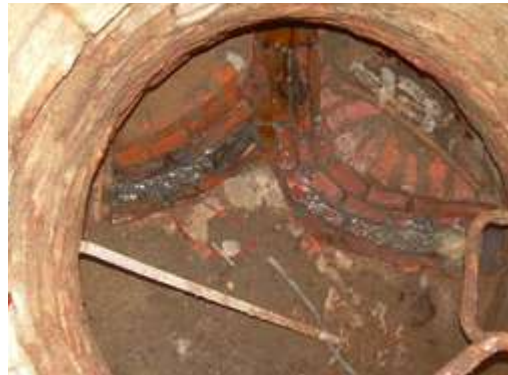
Top View

Corroded steps. Evidence of surcharge - Bench debris.

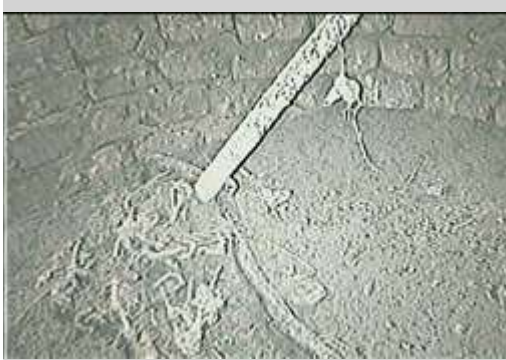
Defect

Barrel deterioration and infiltration. Bench debris.

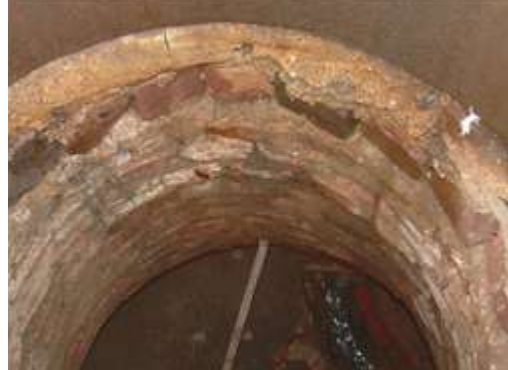
Defect

Frame leaks. Frame offset. Adjustment deterioration, loose brick and infiltration.

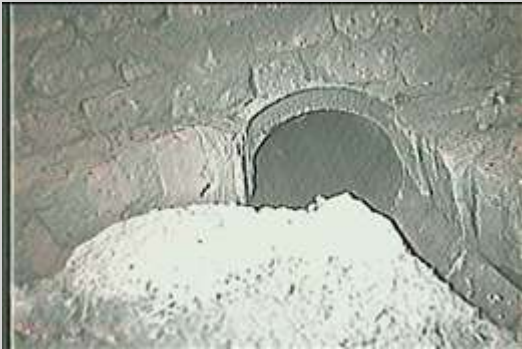
8 in. Circular Gravity Sewer Pipe Out @ 12 O'Clock

Invert Depth: **7.05** (ft.) Flow Characteristics: **Slow**

Deposits: ☒ None ☐ Mud ☐ Sludge ☐ Debris ☐ Grease

Infiltration: **None** Pipe Seal Cond: **Unknown**

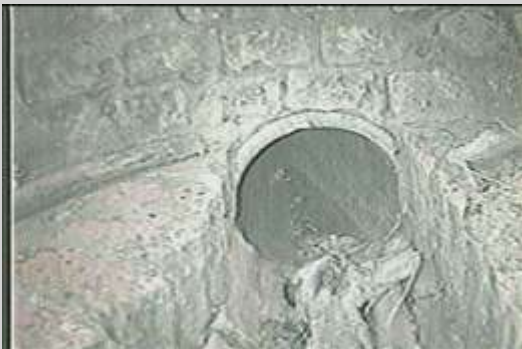
8 in. Circular Gravity Sewer Pipe In @ 3 O'Clock

Invert Depth: **6.70** (ft.) Flow Characteristics: **Slow**

Deposits: ☐ None ☒ **Mud** ☐ Sludge ☒ **Debris** ☐ Grease

Silt Depth: **0** (in.) Deposits Extent: **Light**

Infiltration: **None** Pipe Seal Cond: **Unknown**

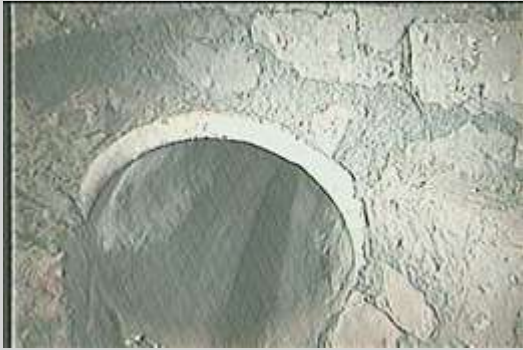
Pipe In @ 10 O'Clock

Invert Depth: **6.48** (ft.) Flow Characteristics: **None**

Deposits: ☒ None ☐ Mud ☐ Sludge ☐ Debris ☐ Grease

Infiltration: **None** Pipe Seal Cond: **Unknown**
